Debris/Ice/TPS Assessment and Integrated Photographic Analysis of Shuttle mission STS-97

Technical Memorandum – 2001 – 208589

January 2001

November 30, 2000

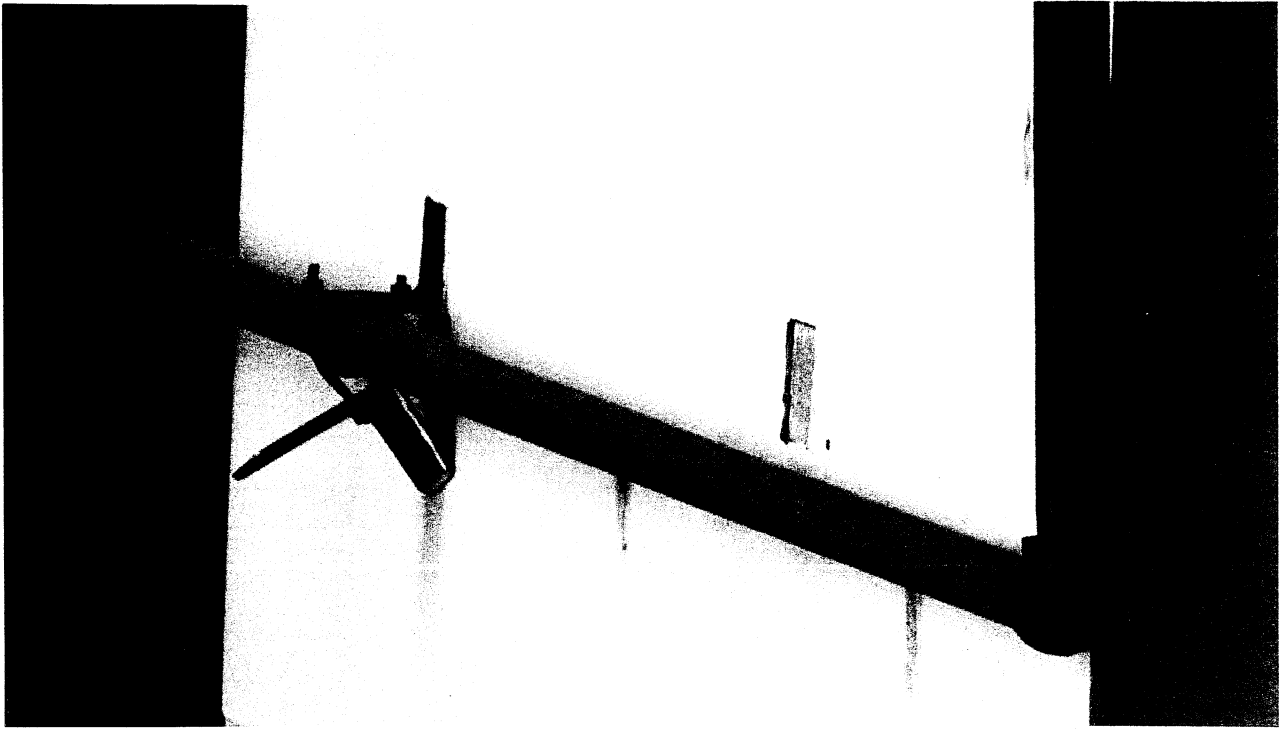
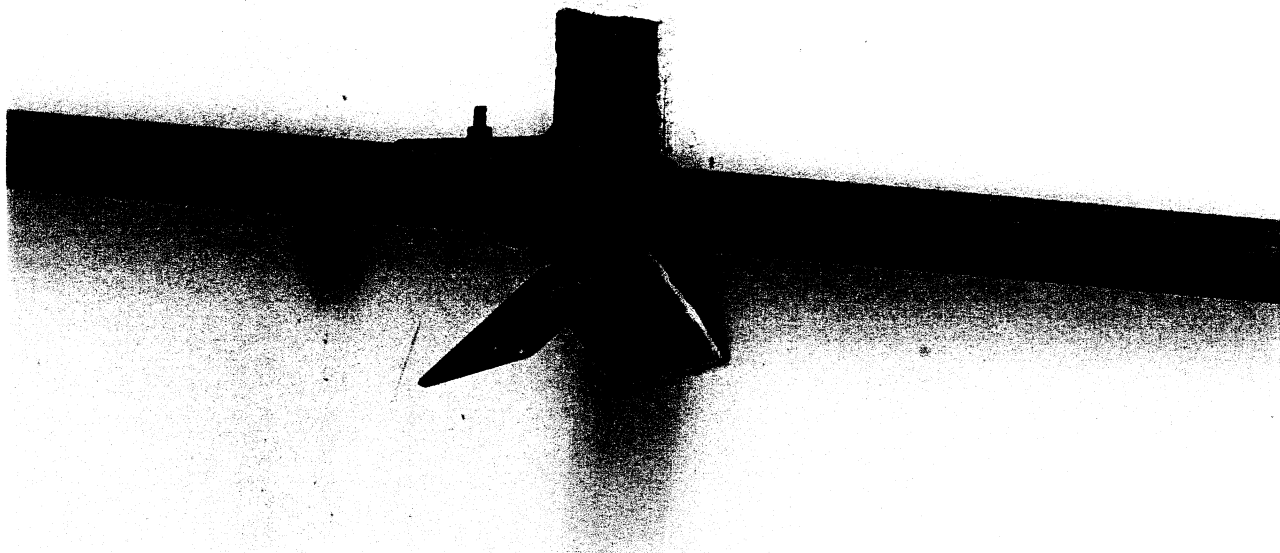
Photo 2: De-attached firex bracket on the OAA

During the pre tanking debris walkdown at T-8 hours, a de-attached firex bracket was observed on the north side of the OAA white room exterior wall. Due to the FOD potential during OAA retraction a decision was made to retract the OAA and remove the bracket. In addition a U-bolt with missing nut on the vertical riser portion of the firex line was replaced and securely re-attached. An action was taken during the S0007 post test debriefing to review pad inspection and maintenance practices and to implement changes to mitigate FOD production and to enhance FOD detection techniques so as to preclude FOD induced launch countdown delays.

During the pre tanking debris walkdown at T-8 hours, a de-attached firex bracket was observed on the north side of the OAA white room exterior wall. The bracket was removed using a Condor Highlift.

In addition, IPR 097V-0110 was taken against Pad facility, during the pre tanking debris walkdown at T-8 hours, a de-attached firex bracket was observed on the north side of the OAA white room exterior wall. Due to the FOD potential during OAA retraction a decision was made to retract the OAA and remove the bracket using a Condor Highlift. In addition a U-bolt with missing nut on the vertical riser portion of the firex line was replaced and securely re-attached. This task delayed ET cryoloading by approximately two hours. The IPR was closed and a facility PR (PV-6-369353) was generated with MRB approval to use-as-is for this flight only.

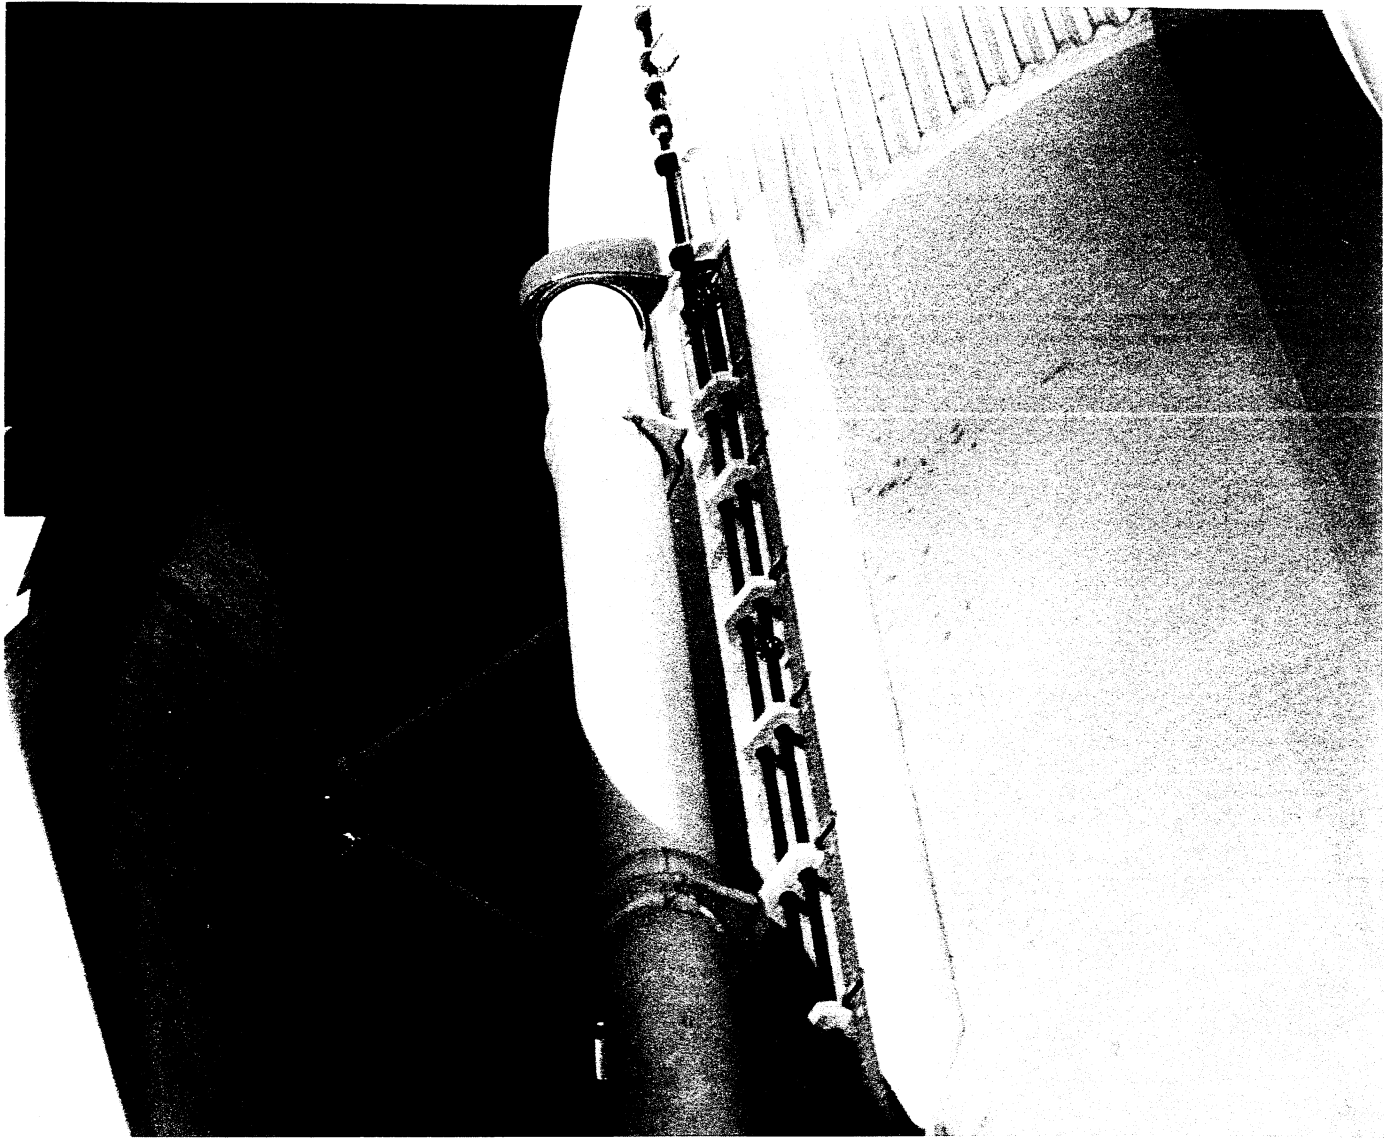
Photo 4: LH2 Tank Acreage

Light condensate was present on the LH2 tank acreage. Surface temperature ranged on the upper 40 degrees Fahrenheit. There were no acreage TPS anomalies.

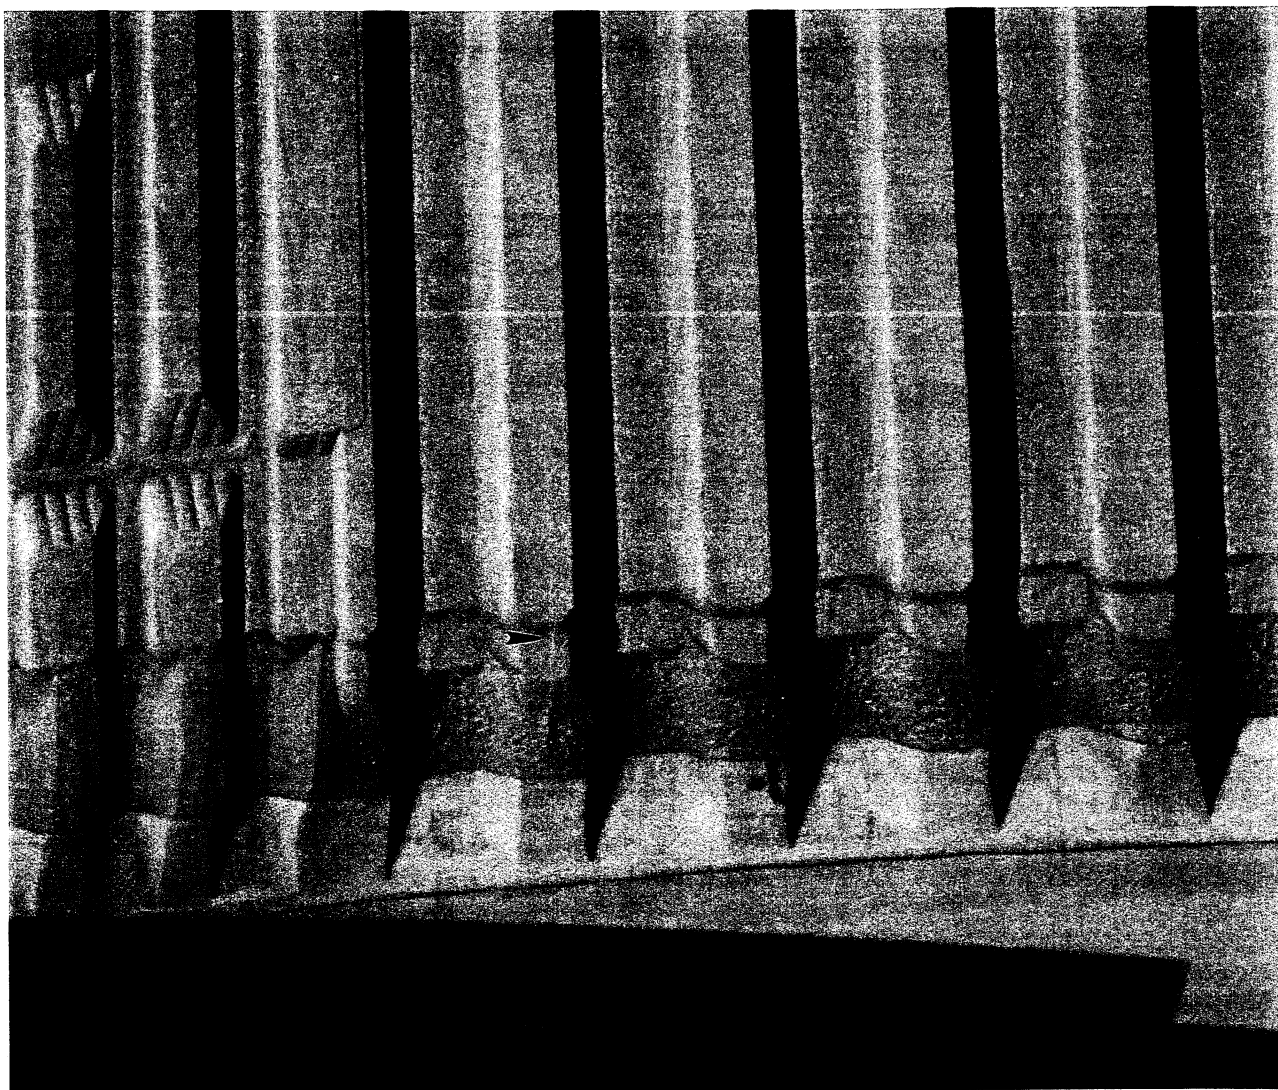
Photo 5: Cracks in Intertank Stringer Valleys

No significant anomalies were present in the intertank TPS. A total of two cracks in the intertank stringer valley TPS were observed (-Y/-Z side and -Y/+Z side). Neither cracks exhibited ice, frost, nor offset. Therefore, the cracks were acceptable for flight per the NSTS-08303 criteria. Ice and frost accumulations on the GUCP were typical.

No significant anomalies were present in the intertank TPS. Two small stringer valley TPS cracks were observed (-Y/-Z side and -Y/+Z side).

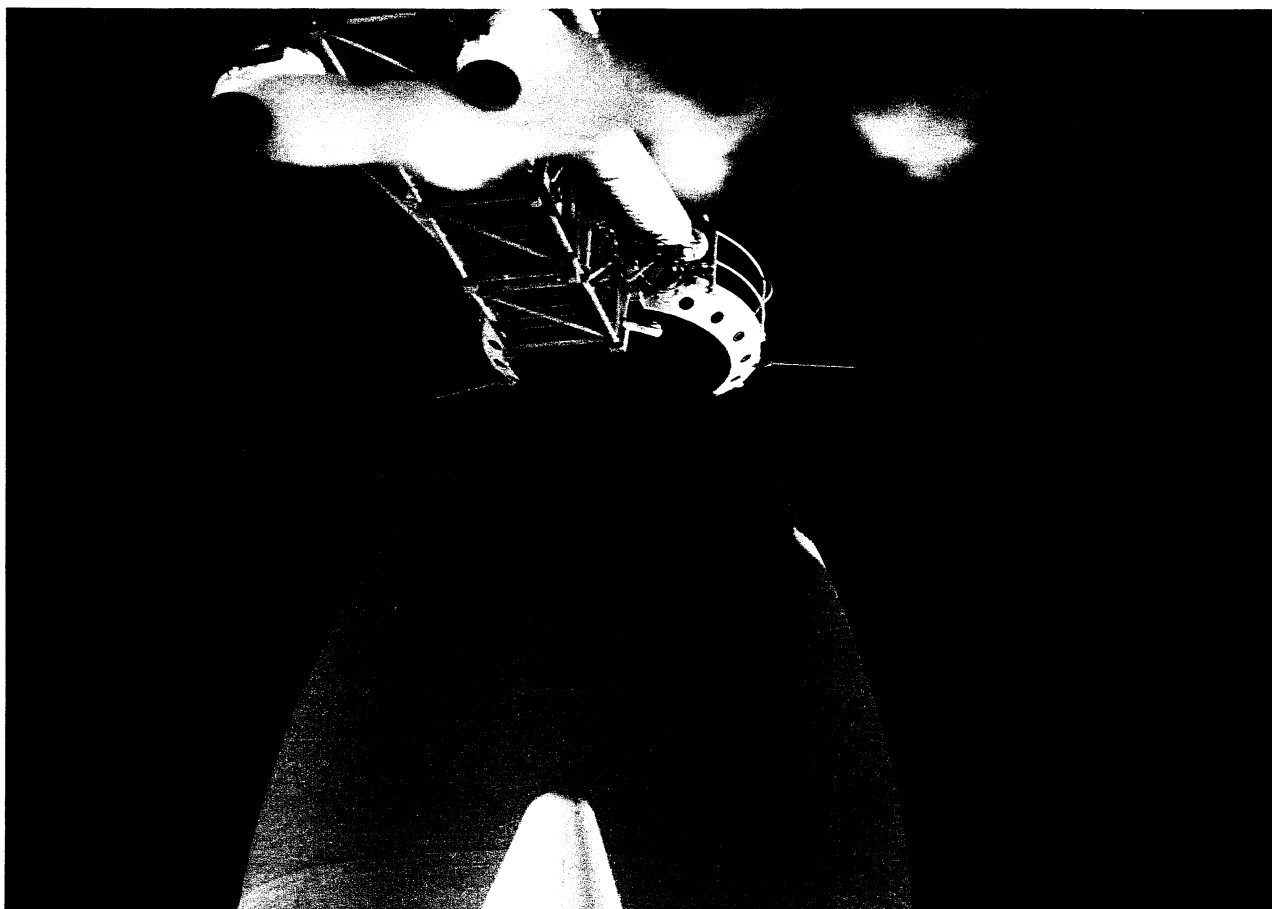
Photo 6: ET LO2 Tank forward

The Final Inspection Team observed no condensate on the LO2 tank acreage. Surface temperatures ranged from 44 to 46 degrees Fahrenheit. There were no TPS anomalies.

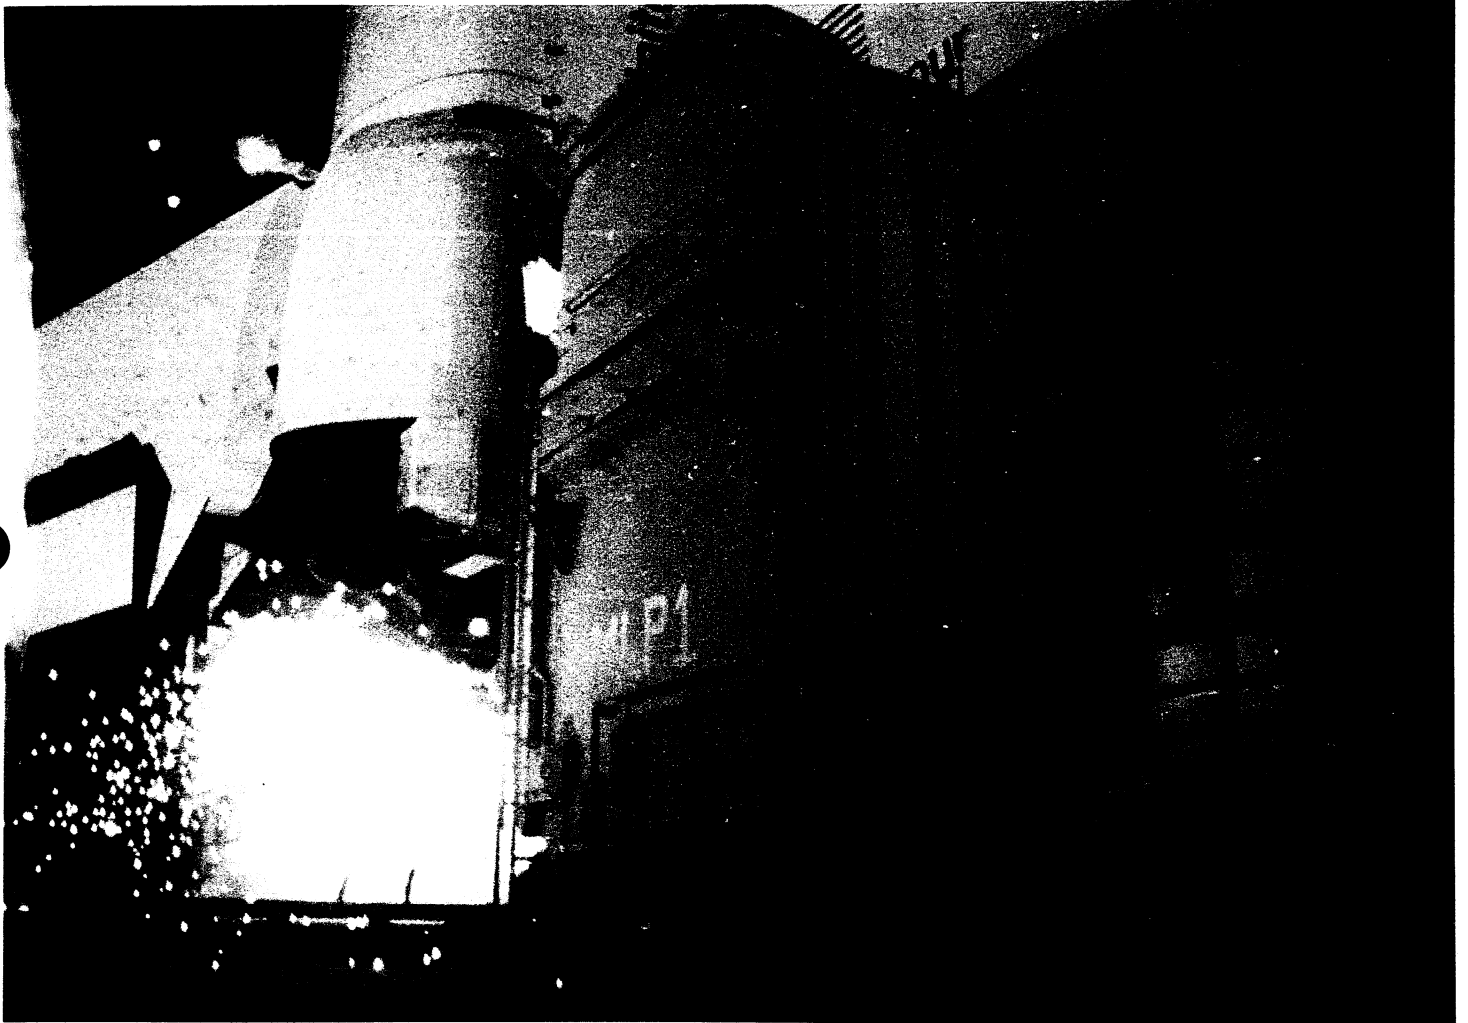
Photo 8: Pulsating Flames from Orbiter APU

Pulsating flame were observed on +Z APU vent exhaust (aprox. 5 feet in length) at the right hand side base of the vertical stabilizer.

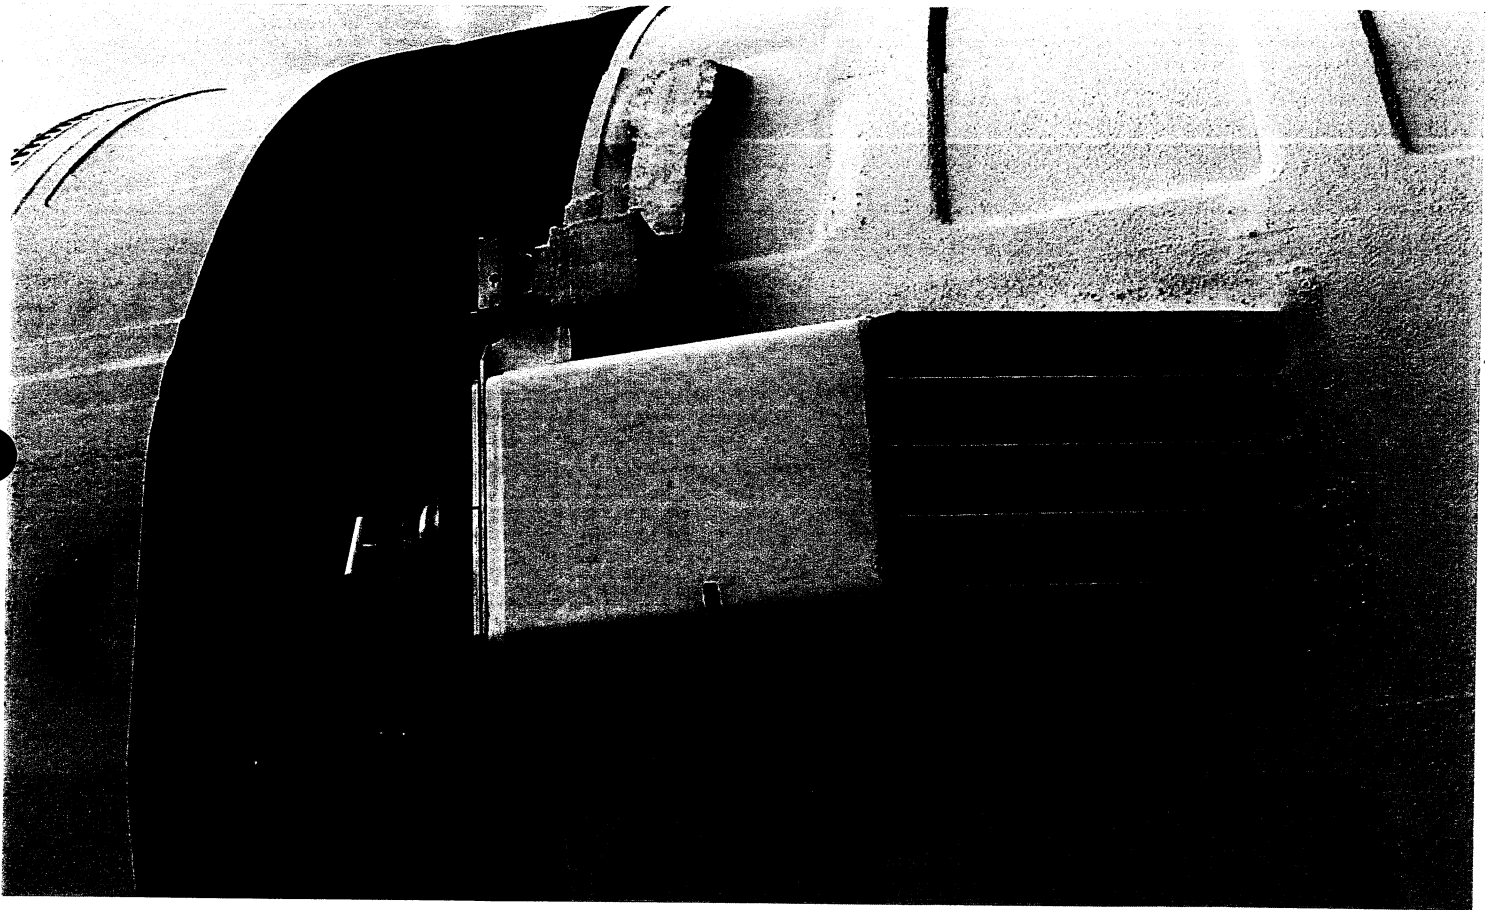
Photo 13: Forward Skirt Post Flight Condition
The forward skirts exhibited no debonds or missing TPS.

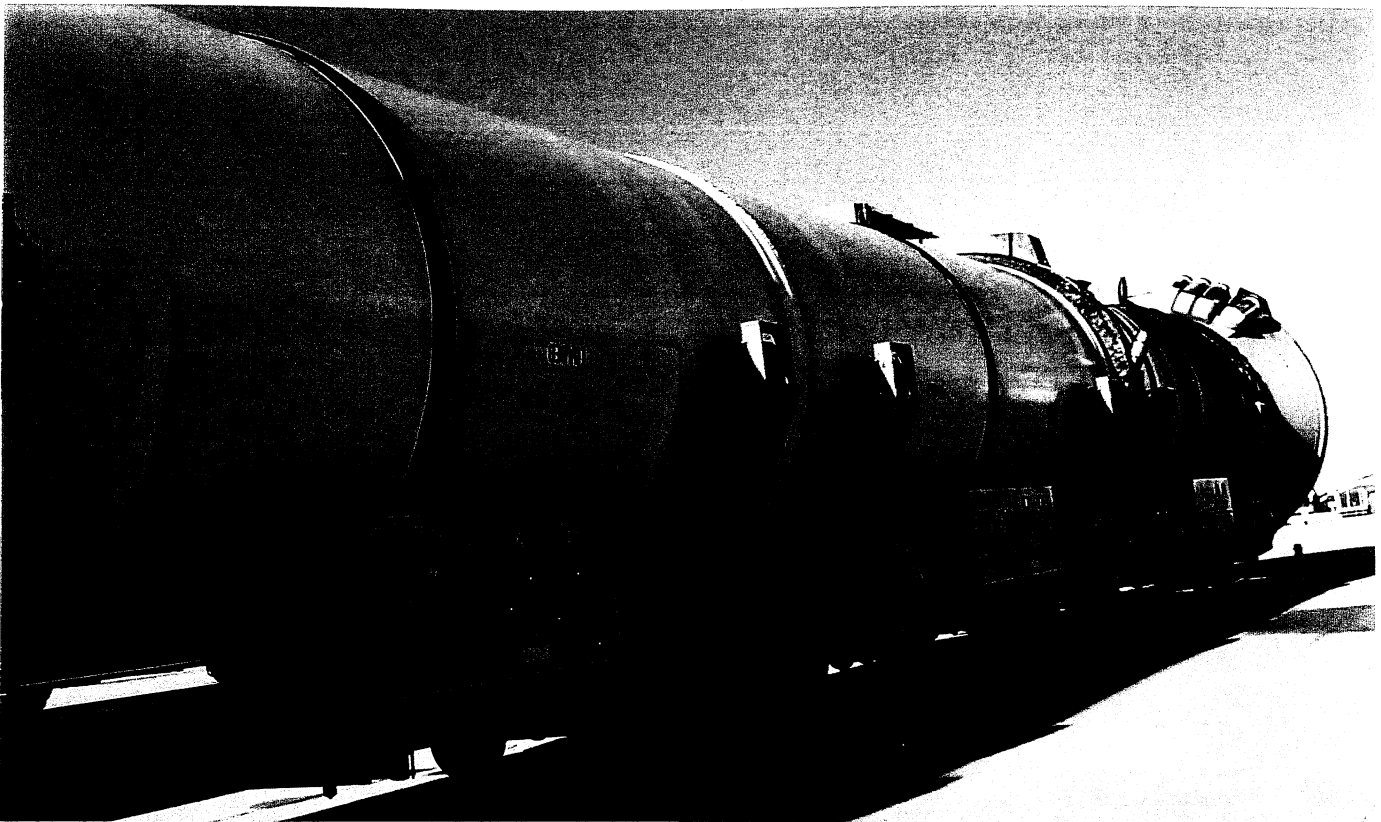
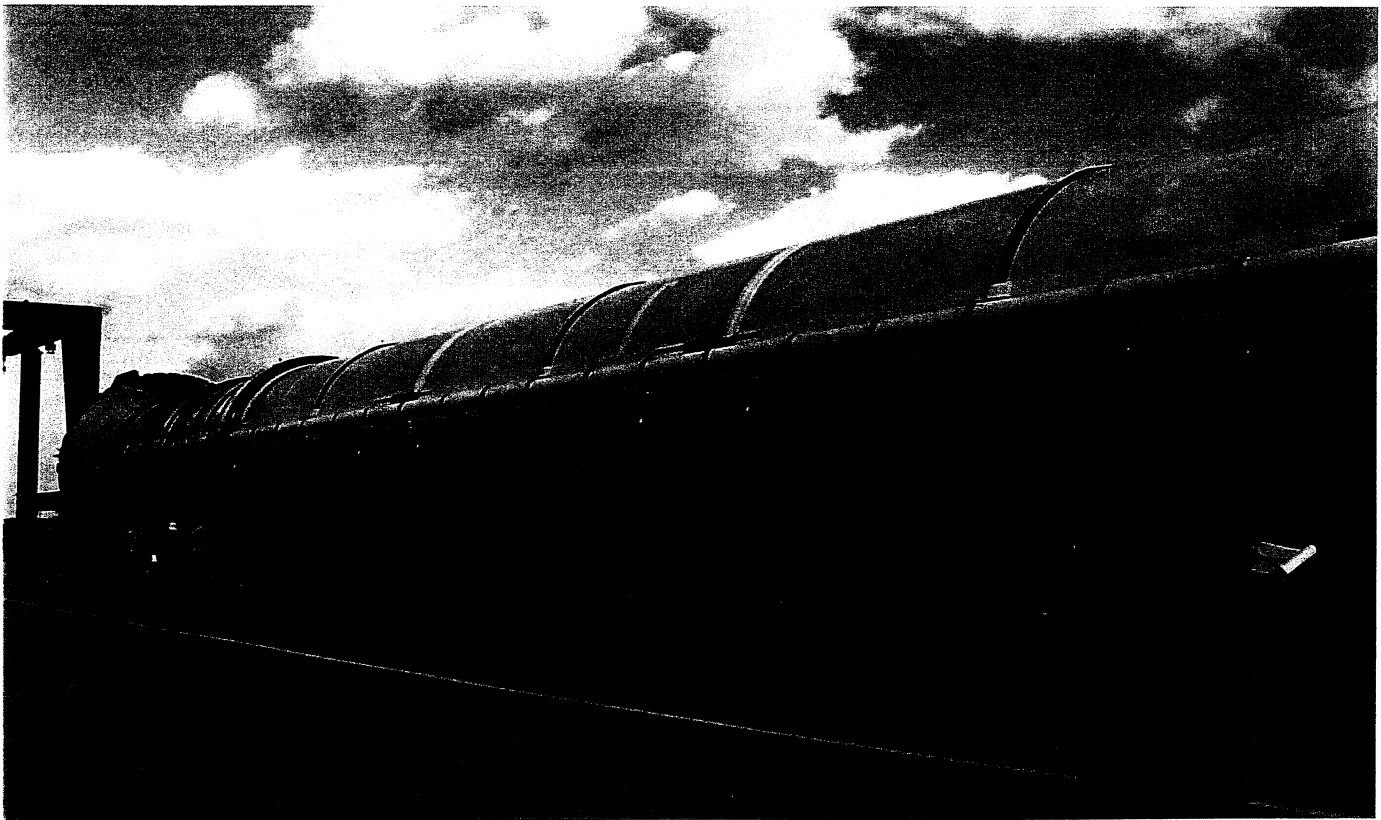
Photo 14: SRB Post Flight Condition

Both SRB's were found in good condition regarding debris assessment

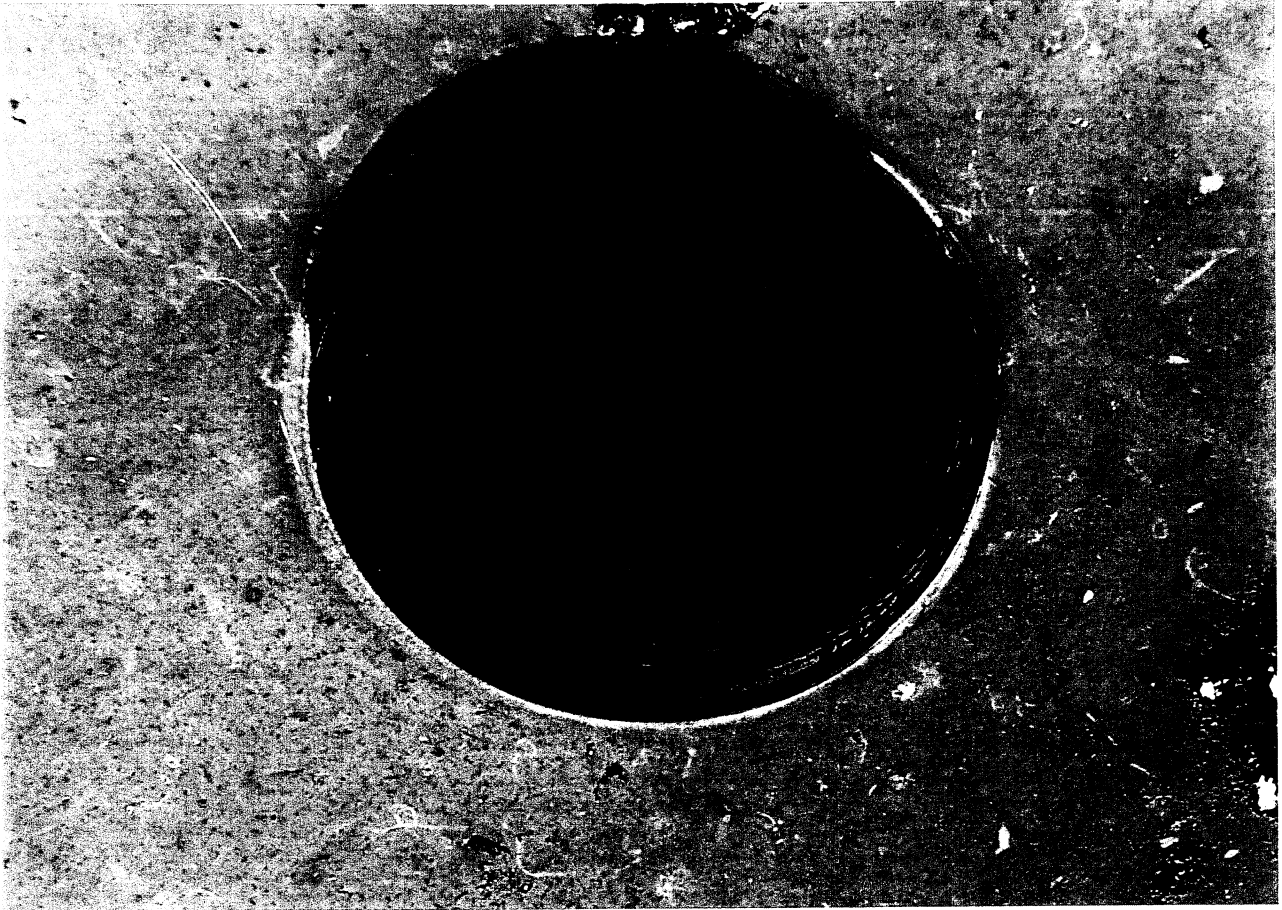
Photo 15: Holddown Post Broaching

There was evidence of a stud hang-up on this launch. Broaching occurred in the holddown stud bore of post #1, consistent with stud hang-up seen in the post launch film reviews. Broached area was generally on the +Z side of the bore.

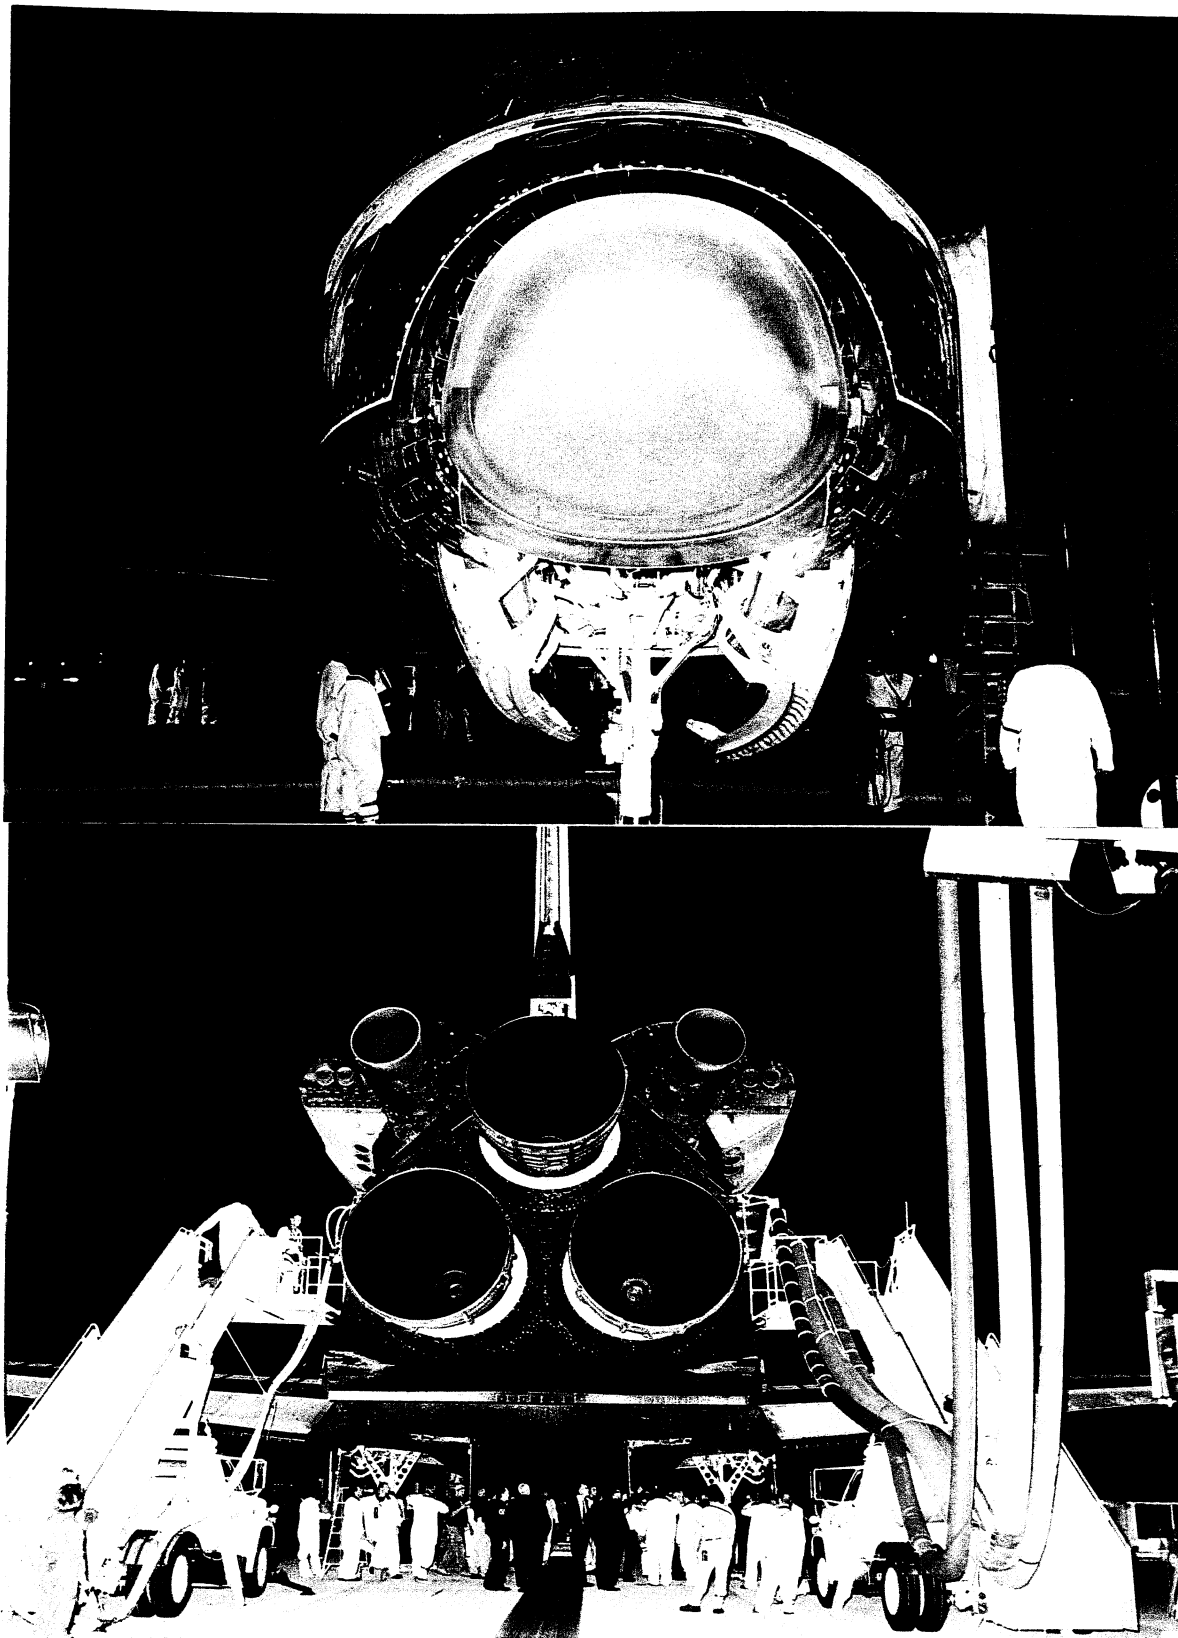
Photo 17: Windows and Base Heat Shield

Damage sites on the window perimeter tiles were less than usual in quantity and size. Also Less than usual amounts of tile damage occurred on the base heat shield. All SSME Dome Heat Shield closeout blankets were in excellent condition.

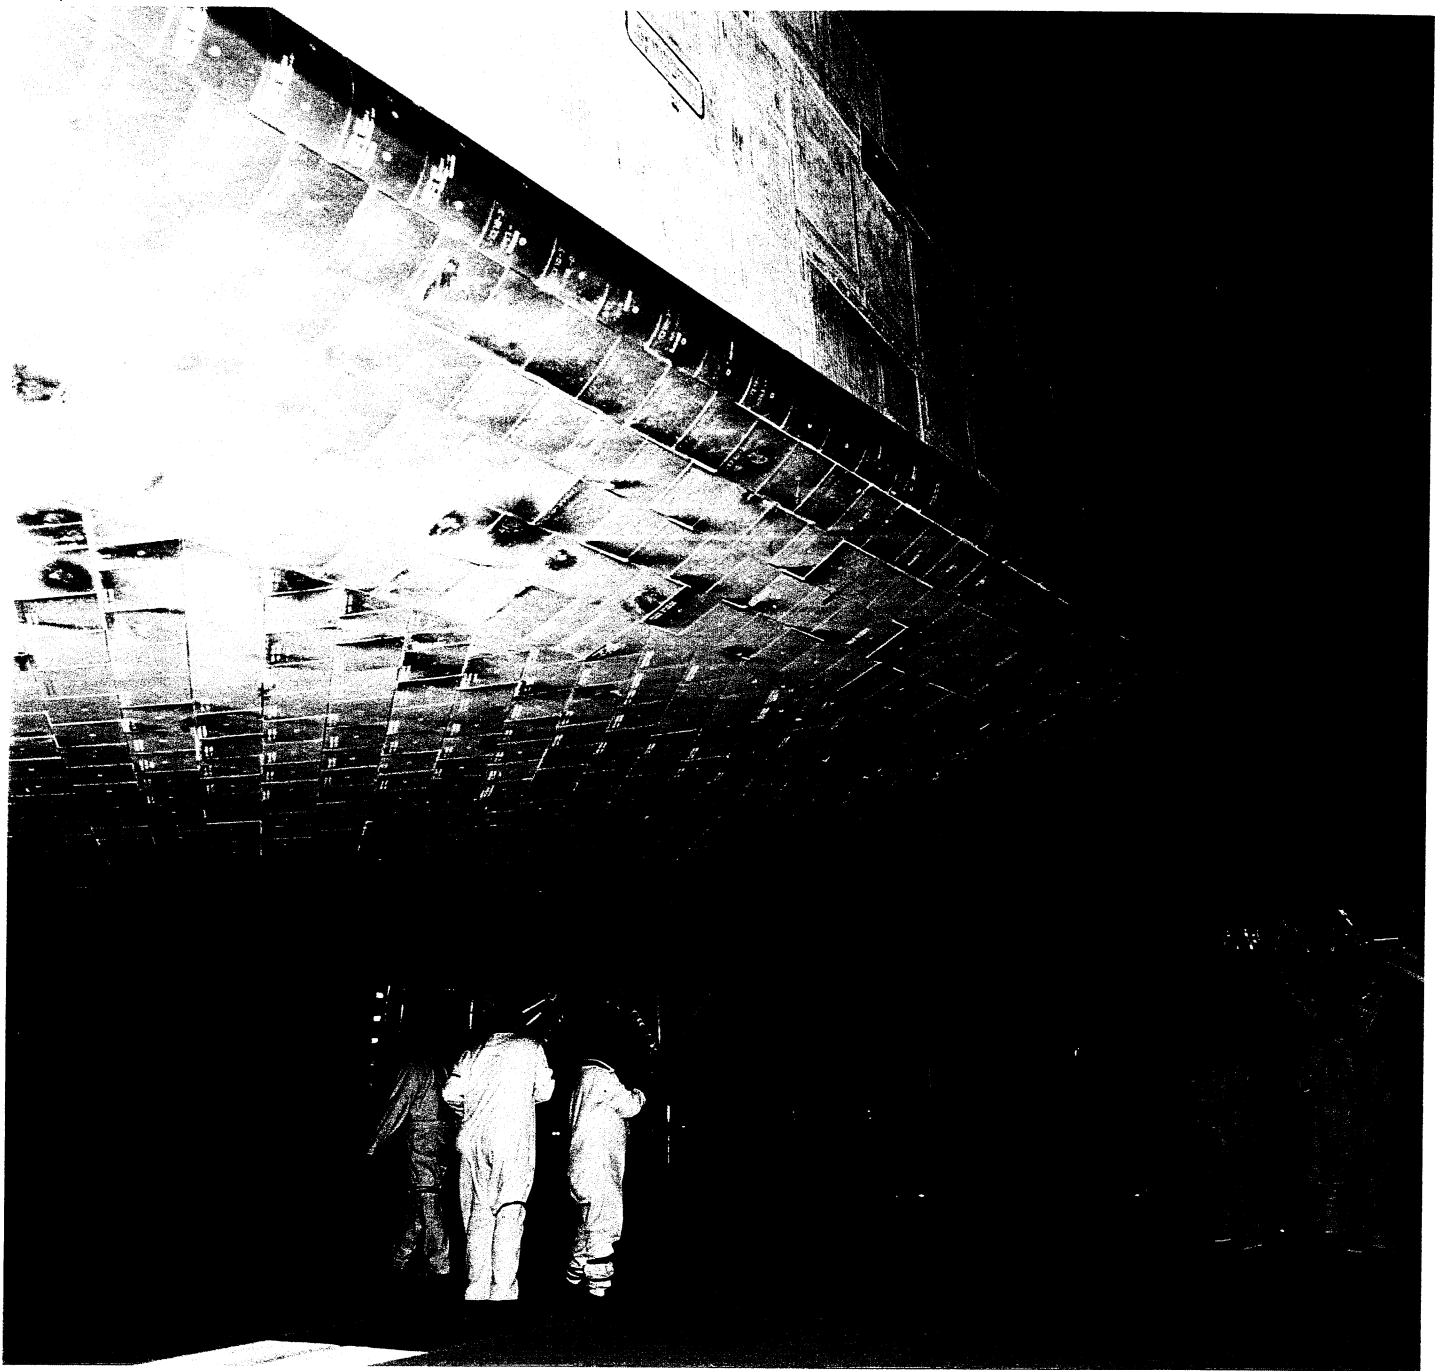
Photo 18: Damage to Lower Surface Tiles .

The orbiter lower surface sustained only 78 total hits. Both the total number of Orbiter TPS debris hits and the number of hits 1-inch or larger were well within established family

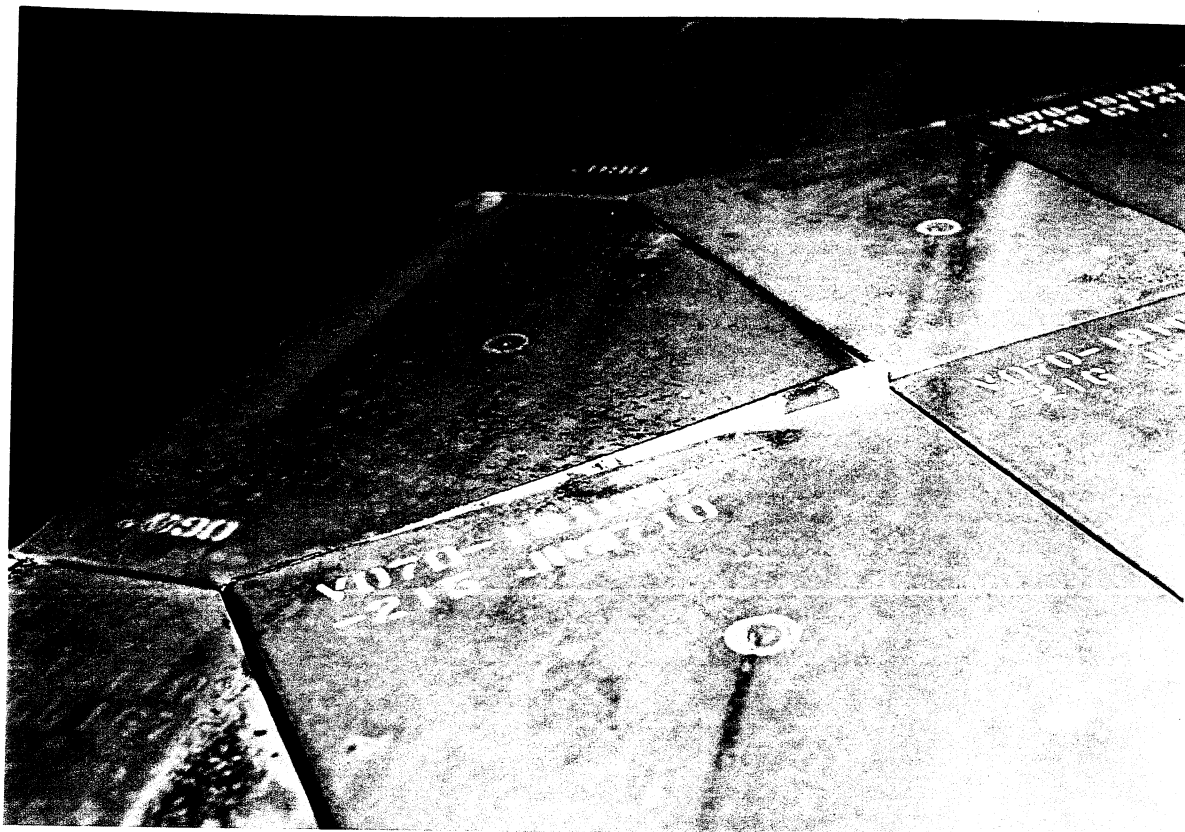
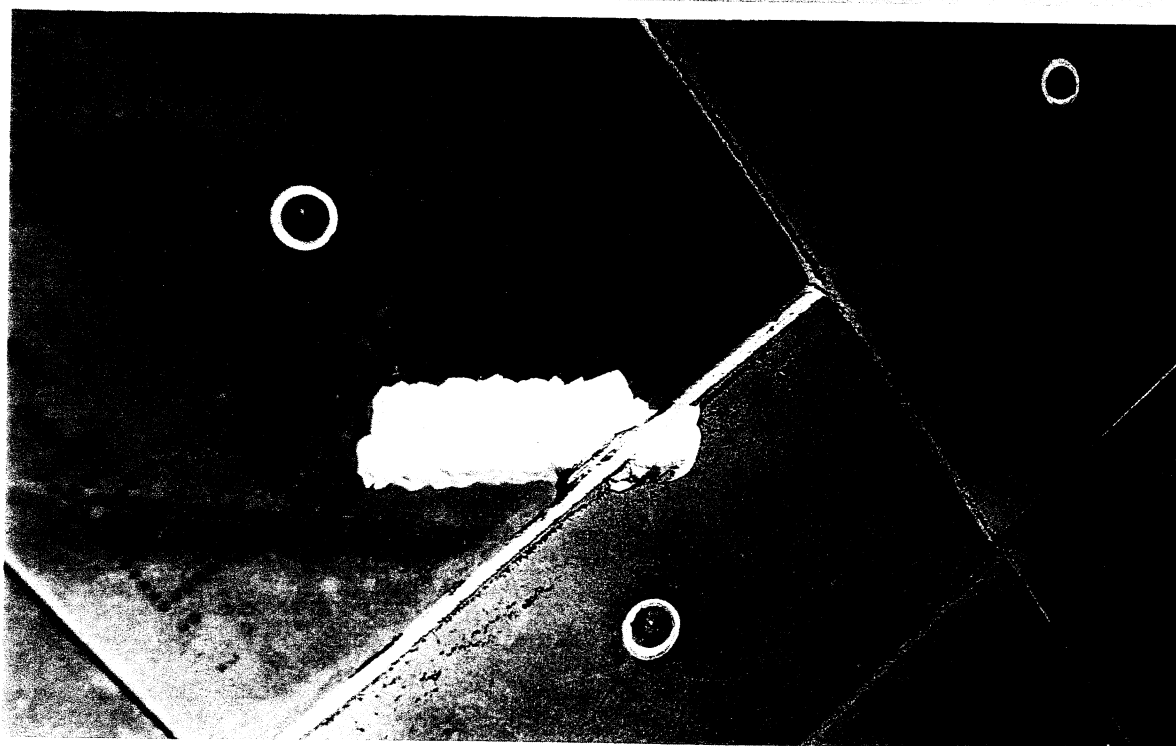
Photo 19: Damage to Lower Surface Tiles

Top photo shows a protruding AMES gap filler found on the L/H Door approximately 0.300" tapering to 0.150". Bottom photo shows the largest lower surface tile damage site. This damage site was located on the centerline immediately forward of the main landing gear, measured 3-inches long by 1-inches wide by 0.5-inches deep, and spans two tiles.

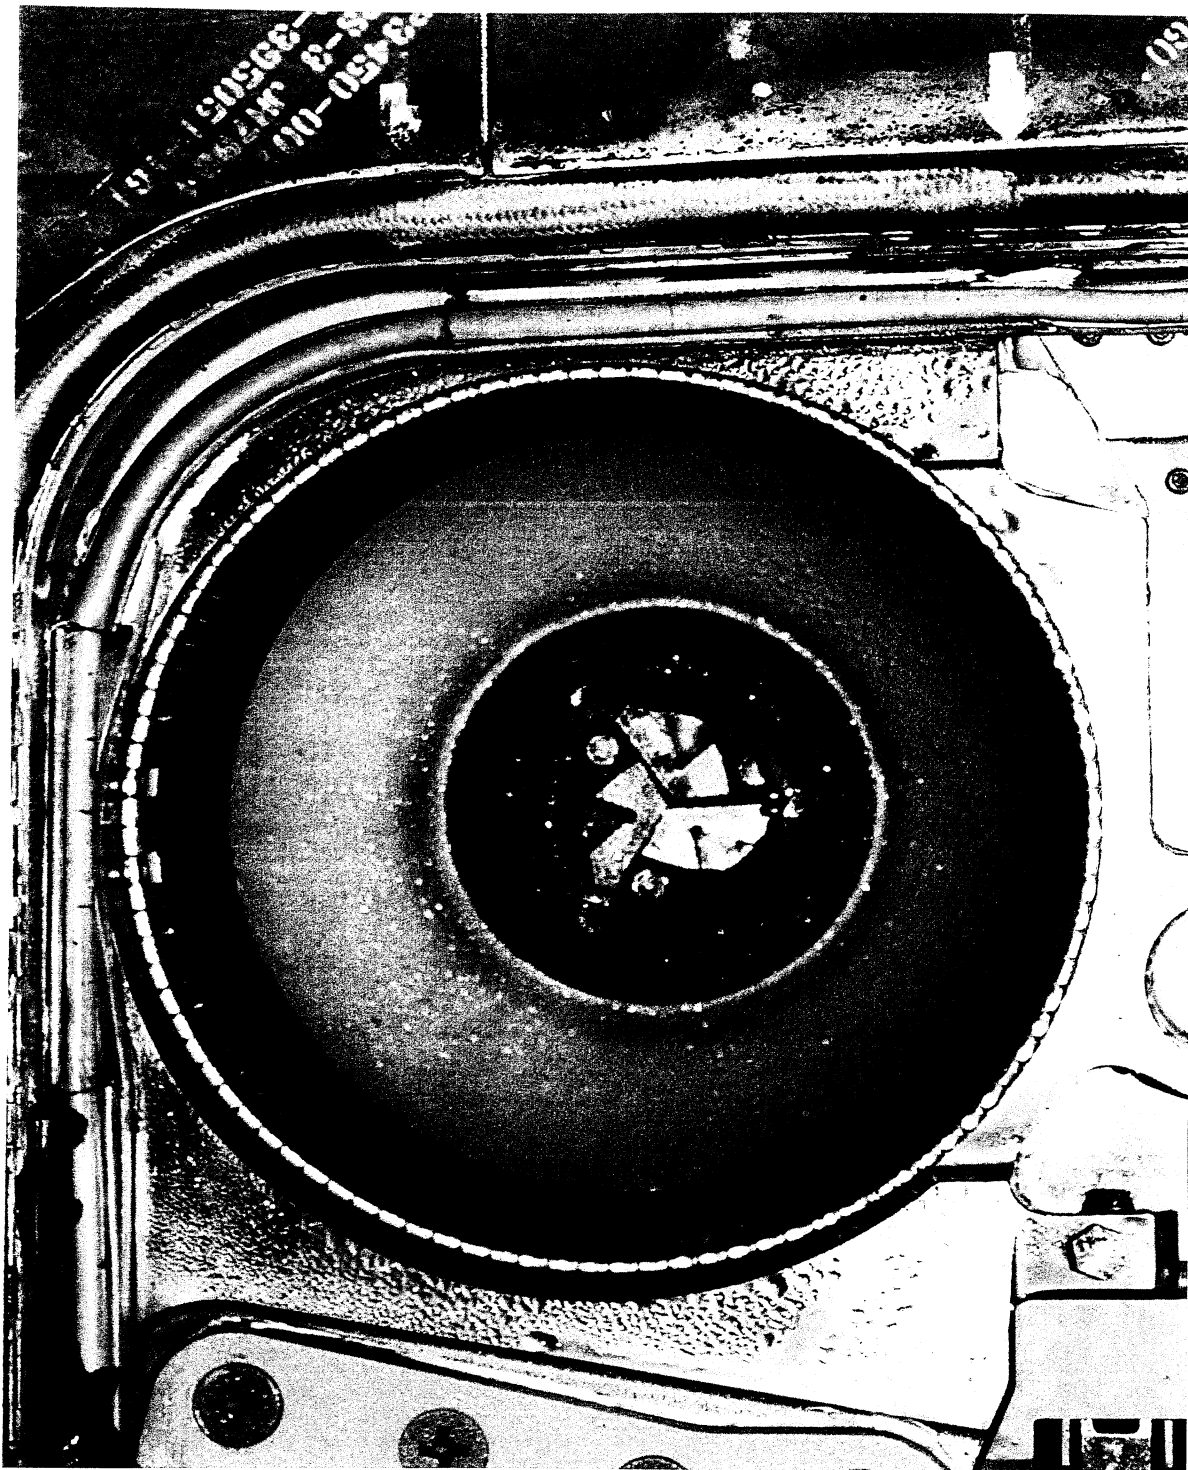
Photo 22: EO-2 Pyro Debris Shutters

EO-2 pyro debris shutters were not fully seated. It was found to be obstructed by ordnance fragment.

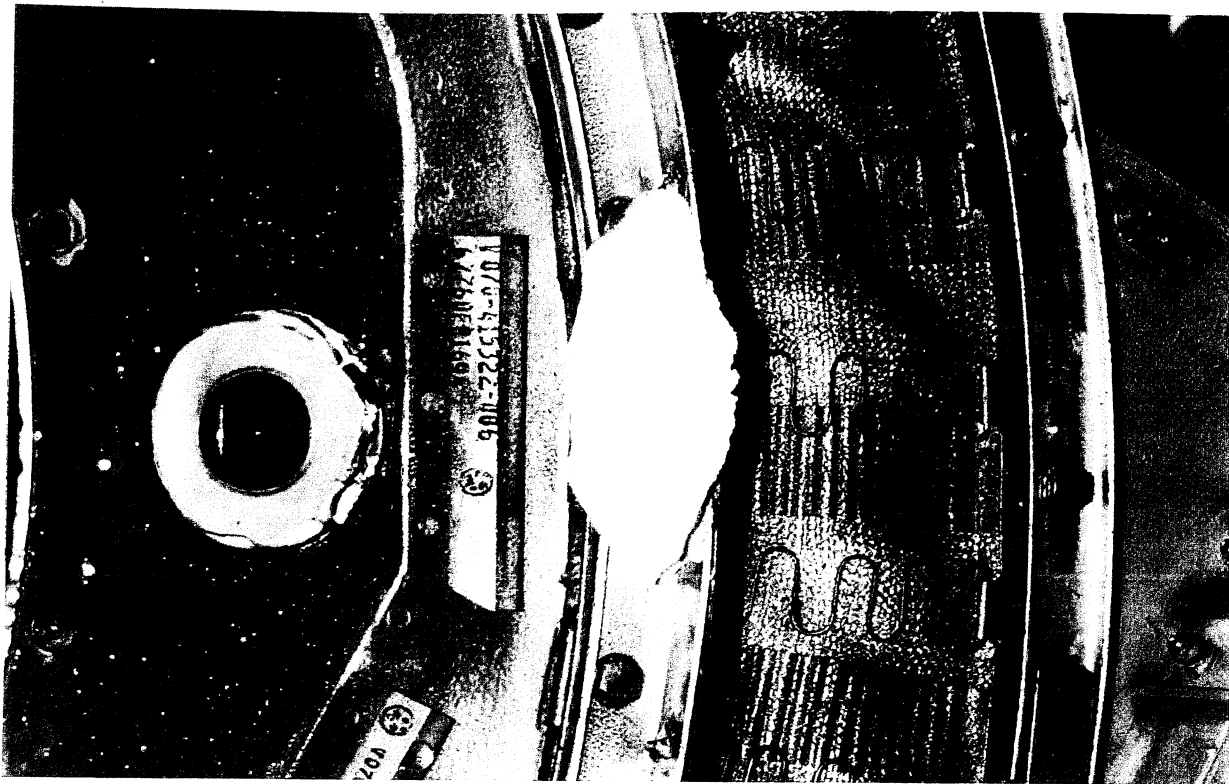
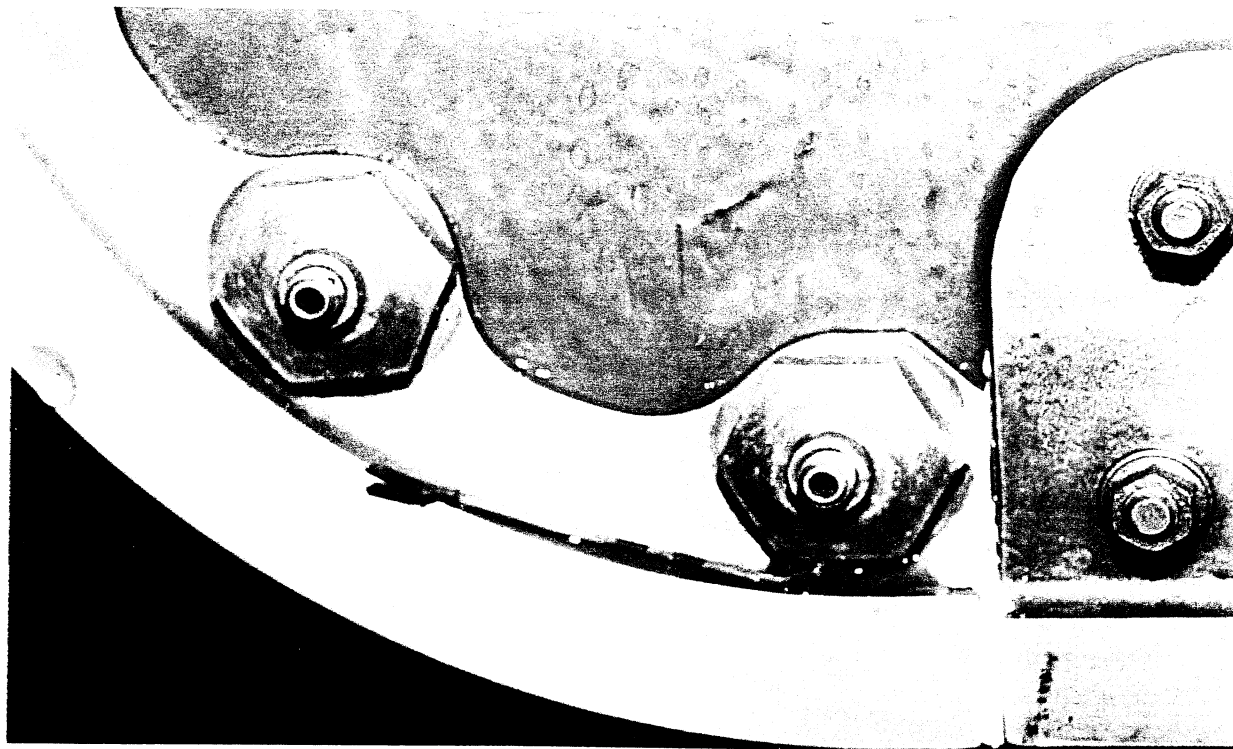
Photo 23: LO2 and LH2 ET/ORB umbilical debris

A piece (3.5" x 1.5" x .75") of umbilical closeout foam (pyro can closeout) was adhered to the umbilical plate near the LO2 disconnect. A 0.06-inch diameter by 1.5-inch long piece of wire with red insulation was found on the ET door LH2 side. This piece of wire was positively identified as a fragment of EO-2 ordnance firing cable.
